International RILEM Conference on Materials, Systems and Structures in Civil Engineering 2016

MAGNESIUM-OXIDE BOARDS CAUSE MOISTURE DAMAGE INSIDE FACADES IN NEW DANISH BUILDINGS

Kurt Kielsgaard Hansen ⁽¹⁾, Tommy Bunch-Nielsen ⁽²⁾, Bent Grelk ⁽¹⁾, Carsten Rode ⁽¹⁾

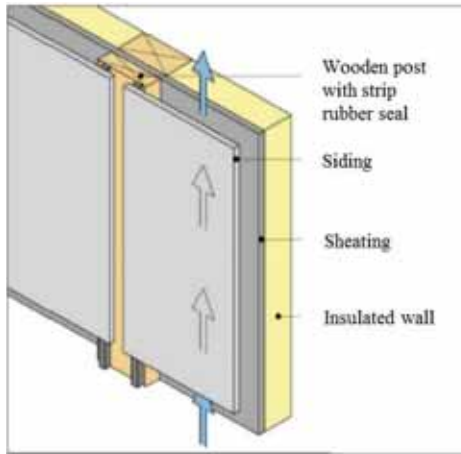
Figure 1: Sketch of a typical façade construction where a sheathing board is used as wind barrier. Adapted from [1].

In winter 2014/15, many moisture damages were observed inside ventilated facades of new or newly renovated Danish buildings. The moisture damaged facades were constructed with sheathing made of magnesium oxide boards (MgO-boards) facing the air gap behind the material used for exterior siding. MgO-boards have often been used as sheathing behind a ventilated air gap as shown in Figure 1 and Figure 3. A photo of a MgO-board is shown in Figure 2.

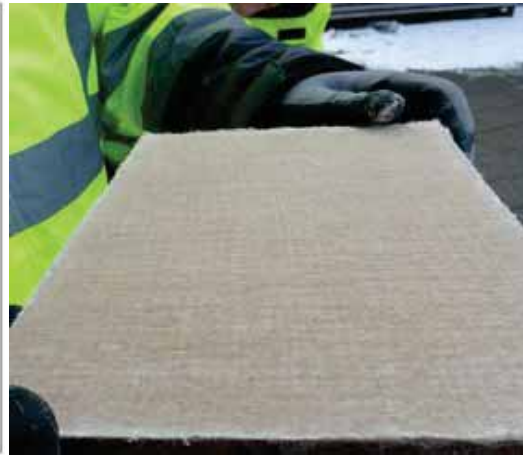
Figure 2: Photo of 8 mm thick MgO-board with a glass fibre mesh on both surfaces.

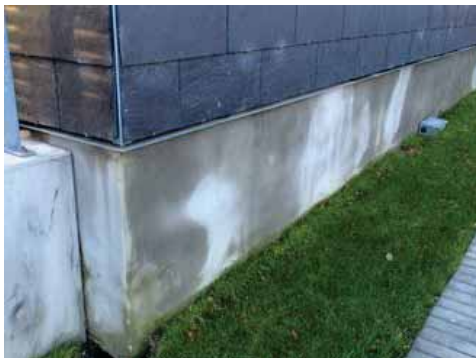
The observed damages were caused by the fact that MgO-boards absorb moisture from outside air. Water drops containing chloride ions appear on the outside of the boards – often so many that they run down the vertical boards and out via the air gap behind the siding boards (see Figures 4 and 5). The metal mountings for the MgO-boards can corrode heavily within a few years, cf. Figure 6.

Figure 5: The water drops containing chloride ions run down the vertical MgO-boards and drain out of the wall from behind the wall's siding boards.

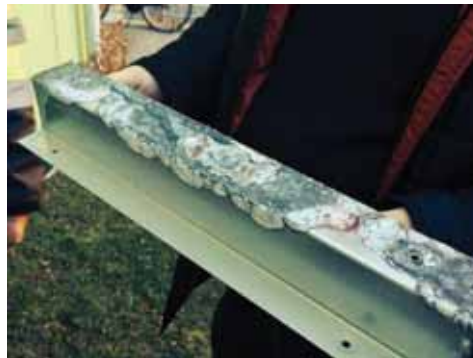
Figure 6: The zink covering of the steel profile is corroded as a result of direct contact with salty sweat or 'tear' drops from the adjacent MgO-board.

sensitive to mould growth due to the content of organic material. Furthermore, the MgO board will itself also be disintegrated over time when it is exposed to high humidity due to the dissolution of the salts it consists of. If metal parts, such as galvanized steel, fasteners and flashings are in contact with MgO-boards, they will start to corrode within short time, leading to safety problems in the structure. Sheathing with MgO-boards are now being replaced by other types of materials in a great number of buildings in Denmark.

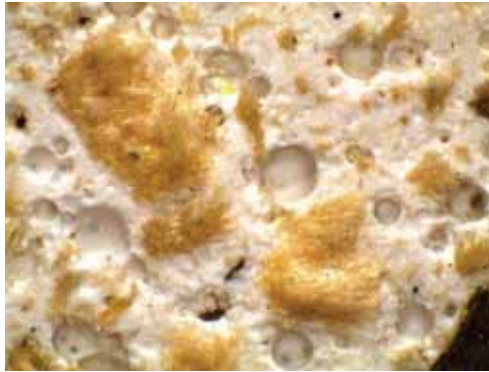
Figure 7: Cut of a MgO-board investigated in a stereo microscope at 10 times magnification.

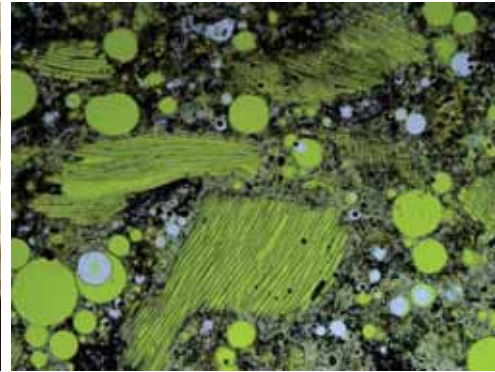
The hydrated product is hard and strong but the product decomposes over time by contact with water or air at high relative humidity (RH). The durability problems with this material are reason that the material has so to speak been forgotten in the following years. However, within the last 10 years a relatively high number of so-called MgO products (MgO-boards) have been put on the market within the building industry. MgO-boards have a composition, which is very similar to hydrated Sorel cement but has both organic additions, such as sawdust (wood flour), and inorganic filler additions such as sand, lime or volcanic ash – even though it may not be stated in the data sheets for MgO-boards. Figure 7 shows a cut of an MgO-board analysed in a stereo microscope at 10 times magnification. The analysis shows that the investigated MgO-board contains a high amount of organic material such as wood fibres or sawdust, and a high number of fine spherical air pores. Figure 8 is a micro analysis of a thin section of a specimen at 50 times magnification that verified both the considerable

Figure 8: Micro analysis of a thin section of a specimen at 50 times magnification.

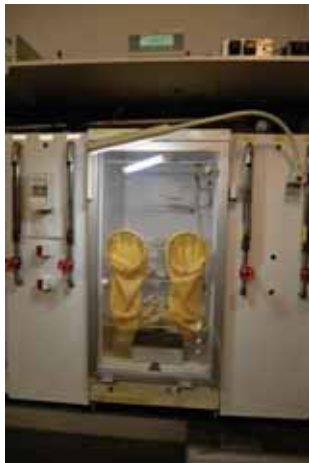
in a petri glass dish, which was placed inside a basket made of Teflon. Weighing of the baskets were performed without opening the front doors of the climate chambers, as the baskets were hung up one by one below the balance by means of a steel string. Figure 9 shows the climate chamber where the actual RH is created by mixing flow of dry air with flow of saturated air. Based on a calibrated RH-sensor the connected PID-system regulates the dry airflow and the saturated air flow for obtaining the wanted RH. In this way, the RH is created in wanted steps. Figure 10 shows the specimens in the petri glass dishes placed in the baskets. The measurements were performed after 0, 1, 2, 3, 4, 5, 7 days and after 2 and 4 weeks. The results are presented in Figures 11, 12 and 13. Indication of mould growth on specimen 4.4C was seen after 30 days of exposure to 95% RH, cf. Figure 14.

Figure 9: The climate chamber.

Subsequent measurements of absorption and desorption were performed for the same four specimens that were analysed for initial moisture absorption at 35% RH and 80% RH, i.e. the initial dry masses were known. The climate chamber used is shown in Figure 9. Desorption was measured for specimens 3.1B, 3.2B, 4.4B and 4.7B, which originally were used for determination of initial moisture absorption at 80% RH. Before starting the desorption runs, the humidity of the climate chamber was increased from 80% RH to 92% RH in steps of 2% RH with the purpose of finding the level of RH at which the specimens began to form drops (i.e. sweating or 'crying') on the surface. We knew from the first part of the tests (at 95% RH) that specimens showed severe sweating starting after one week, while boards at 80% RH apparently did not sweat after 80 days of exposure. In view of the risk of mould growth at RH higher than 92% RH, desorption was started at this RH. Desorption points were measured from 92% RH and below.

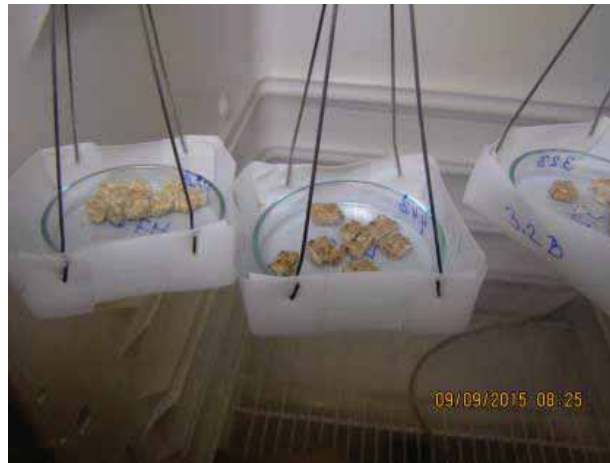
Figure 10: Specimens in the petri glass dishes placed in baskets.

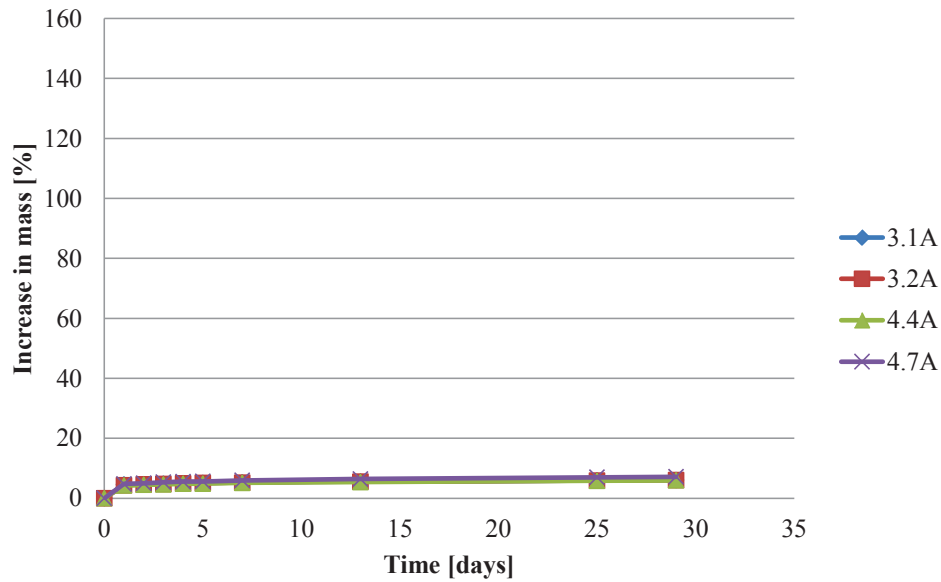
Figure 11: Course of the moisture retention at 35% RH.

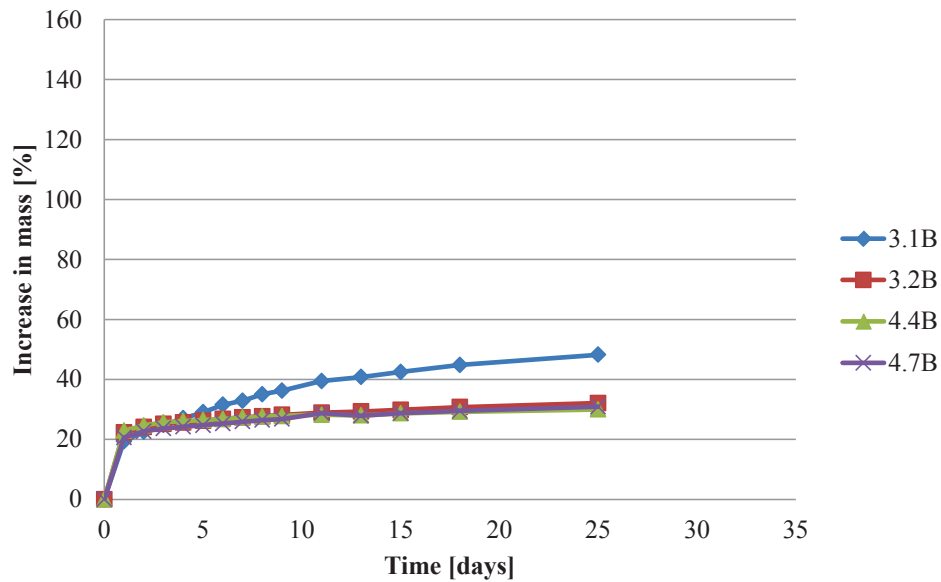
Figure 12: Course of the moisture retention at 80% RH.

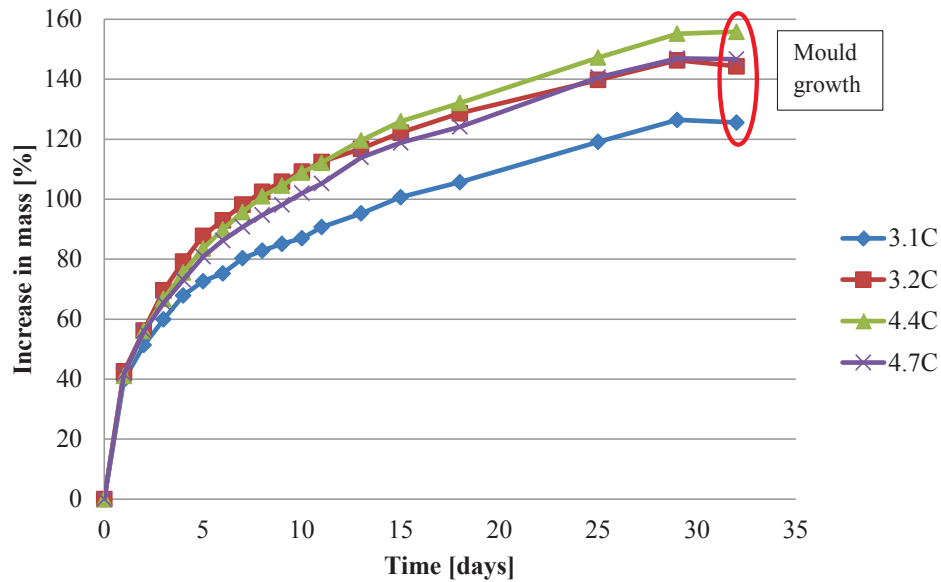
Figure 13: Course of the moisture retention at 95% RH.

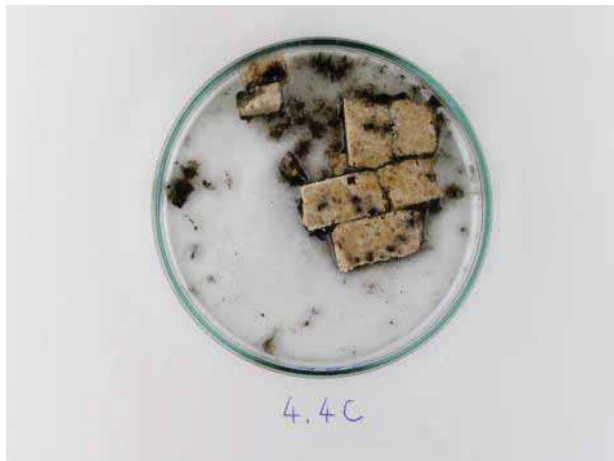
Figure 14: Indication of mould growth on specimen 4.4C after 30 days of exposure to 95% RH.

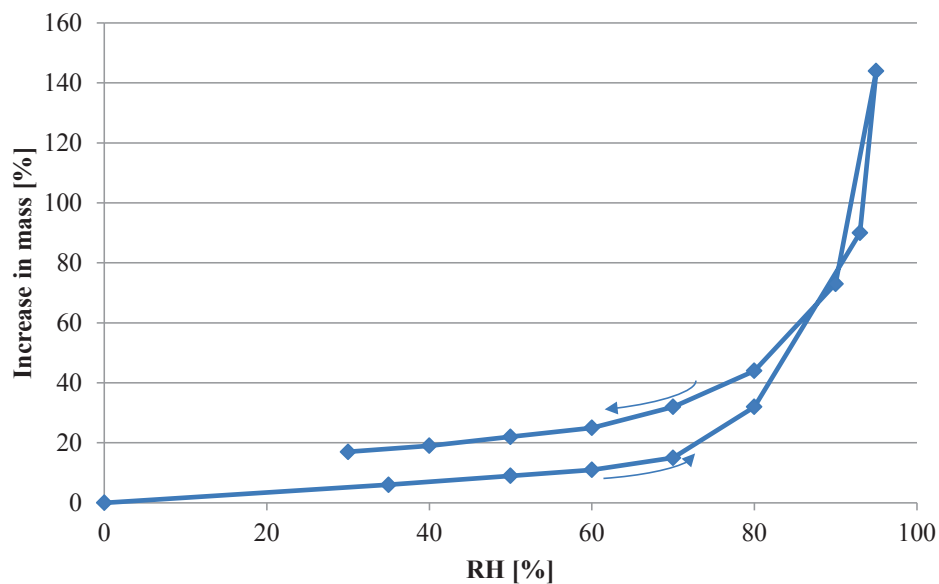
Absorption was measured for specimens that were originally used for initial moisture absorption at 35% RH. The absorption points were measured from 35% RH and up to 92% RH. An example of the results of the absorption and desorption measurements is shown in Figure 15.

Figure 15: The results of the absorption and desorption measurements for specimen 3.2.

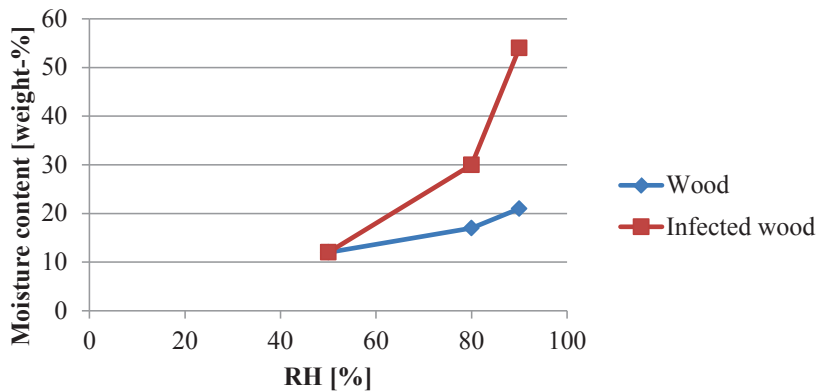
The pine wood posts supporting the adjacent MgO-boards inside the façade construction absorb the water drops ('tear' drops) from the MgO-boards. The 'tear' drops contain relatively high amounts of chloride ions. Infected wood from a post from a house, as well as non-infected wood, have been used for absorption measurements as follows: First, the infected wood and the non-infected wood pieces were conditioned to attain equilibrium at 50% RH. They were then conditioned to equilibrium at 80% RH, and finally to equilibrium at 90% RH. The absorption curves for the infected wood and the non-infected wood are shown in Figure 16.

Figure 16: The absorption curves for the infected wood and the non-infected wood.
